THE LAKE JACKSON VOICE

November 2022

VOLUME 1 ISSUE 2

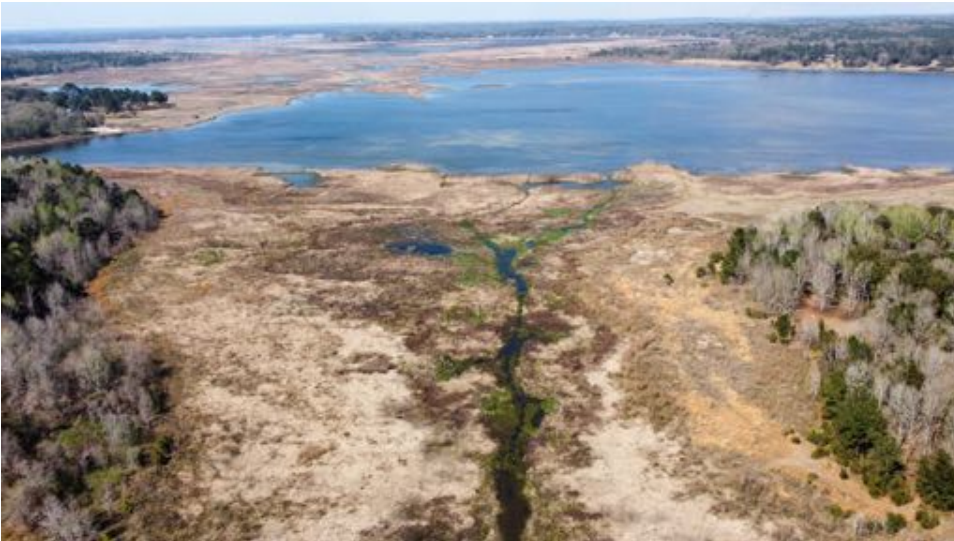
This drone photo of Lake Jackson, courtesy Sean Ruane, was taken from the very dry northern part of Meginniss Arm on 02/27/22, while investigating the possible effect on Lake Jackson of a Feb.5 sewage spill in the southern part of Meginniss Arm. See the Ecological News column for more on the spill. See the Arts & Culture column for more on the Meginniss spelling.

We were also puzzled by the City's conclusion that no contamination had reached the southern part of Lake Jackson. A City crew had taken the precaution to explore the area at the mouth of Meginniss Arm on Feb. 8, found it dry, and concluded that there was no connection between Meginniss Arm and the open lake, even though an *E. coli* sample taken by the City crew in the area returned a value of 376, just short of the 400 threshold. It is worth noting that FDEP measured a value of 134 in the vicinity on Mar. 8, 22 (station G1TLHR0124), a month after the spill. Values usually measured there (as retrieved from WIN) are typically 1 or 2 orders of magnitude smaller. A kayak trip and a subsequent drone flight showed that a small, narrow but continuous flow did connect Meginniss Arm to the open lake, with an outlet apparently east of the area explored by the City. See the drone photo on the front cover of this issue.

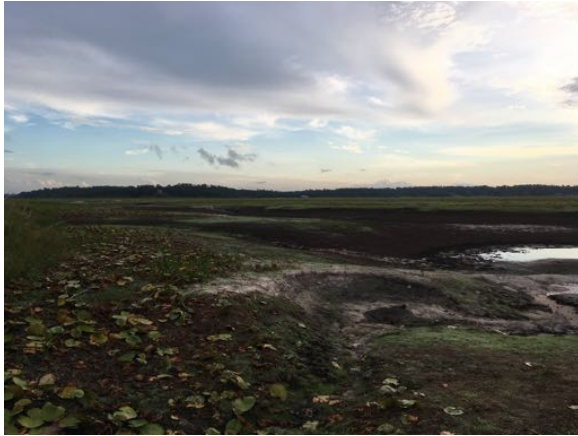
View from Faulk Dr. Landing, looking northeastward at sunrise on July 10

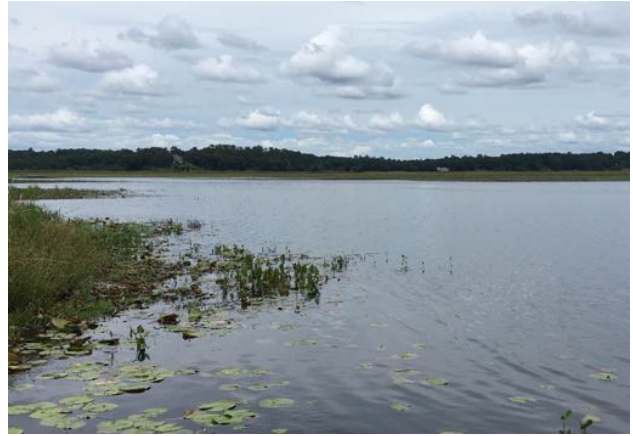
Same view on July 15, 22 after 2 ¾ in of rain fell on July 11

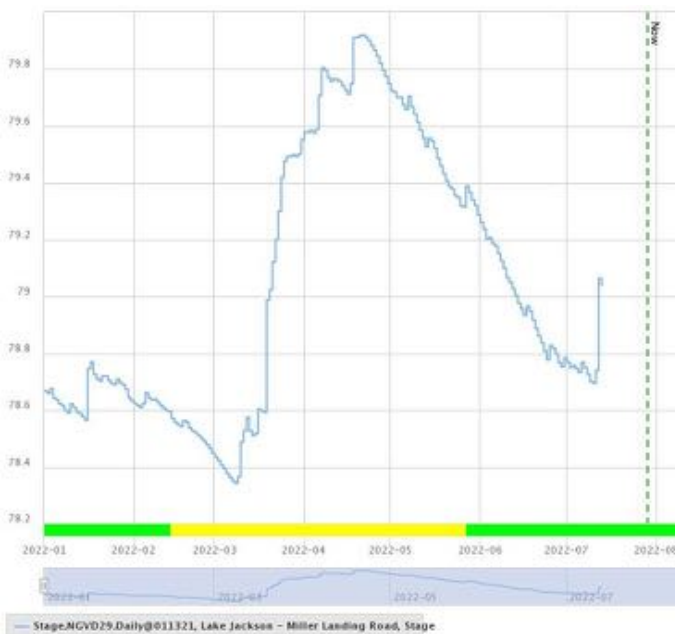
Consider the following figures, featuring the water level – stage – (first figure) and the precipitation (next figure) at the Miller Landing Northwest Florida Water Management District (NFWMD) gauge from January to mid July 2022 and generated from the NFWMD portal.

Values for the water level are in feet above mean sea level, aka ft msl (referenced to NAVD88, do not ask). The mean elevation over the whole period was roughly 79 ft, and changed by less than 1 ft above and below that value, from a minimum of 78.35 ft in the first half of March to a maximum of 79.9 ft in mid-April.

For context, the mean lake elevation at “full pool” is around 86 ft, whereas, around 78 ft, the lake is separated into distinct sub-basins with distinct elevations, dramatically so when the Porter Hole Sink basin goes dry. (See bathymetric map in the Ecological News column.) The mean January-July elevation was thus 7 ft below full pool. Porter Hole Sink was exposed during most of February, and then again in early July.

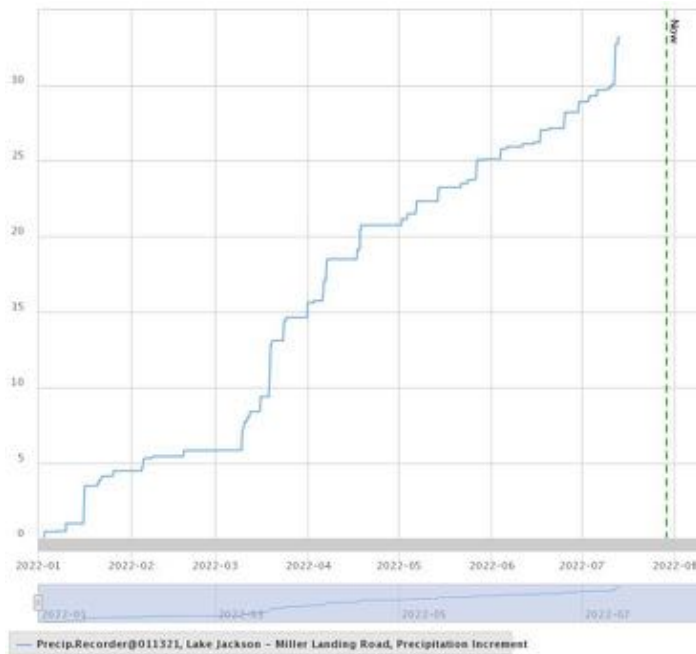
Values for precipitation are in inches and plotted as an accumulation, which is why the curve is always going up. When the curve is flatter, there is little or no rain, and the stage curve (above) goes down because of unabated evaporation and bottom drainage. See the mid January to beginning of March period, and the mid April to beginning of July period.

During heavier rains, the curve of precipitation increments becomes more vertical, and the stage curve goes up (despite unabated evaporation and bottom drainage). See the small mid January event, and the sustained series of events from beginning of March to mid April that amounted to over a foot of rain and thus over a foot in elevation gain.

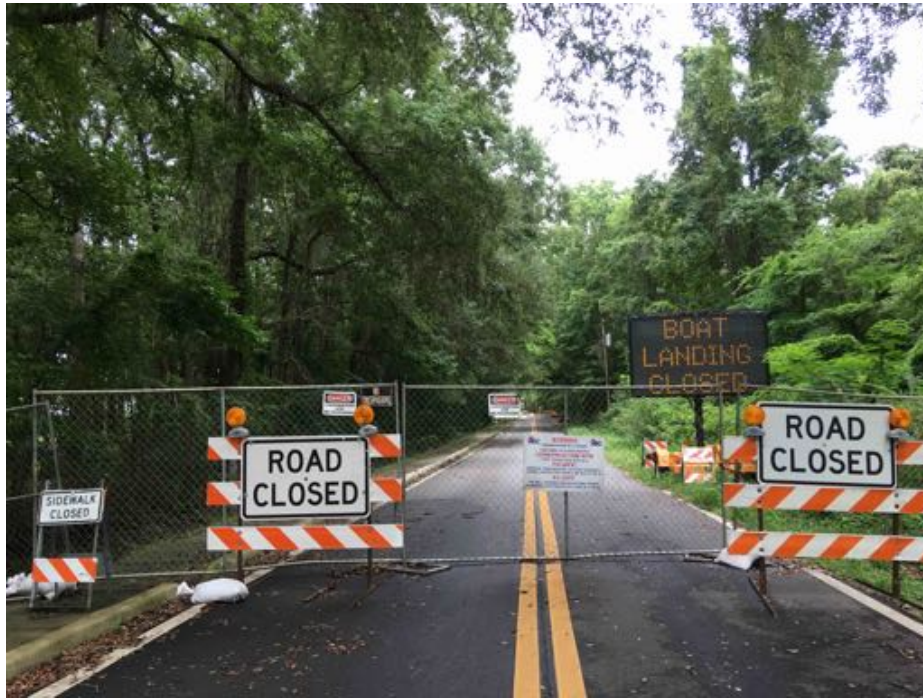
Crowder Landing Rd closed to allow repair and improvement work at Crowder Landing. Expected completion end of November 2022.

More water should have favored boating temporarily, but paradoxically the one remaining landing with enough water to launch vessels larger than a kayak, Crowder Landing, has been closed for repair and improvements. Vehicles and foot traffic are all impossible as Crowder Rd itself is closed ahead of the landing. The Leon County Department of Public Works, in charge of the landings, is working on:

- replacing the Boat Launch Ramp
- replacing failing pipes and retaining walls
- stabilizing the western shoulder of Crowder Road to reduce sediment load into the lake
- sprucing up the landscape and adding a shelter

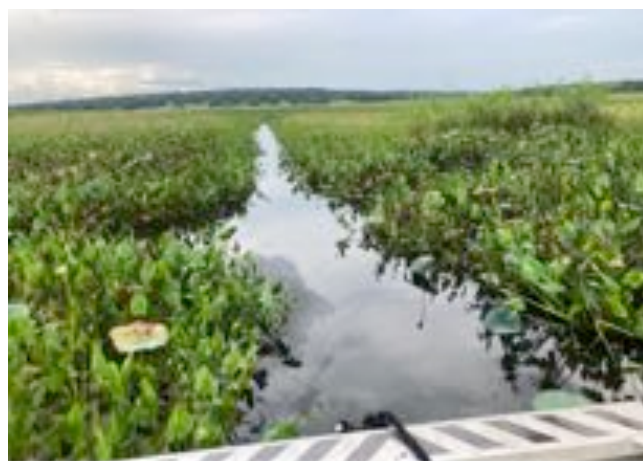
Narrow channel across the central lake vegetated barrier

An extensive shallow area extends diagonally across the mid-lake from the Lake Breeze neighborhood shoreline on the southwest to the undeveloped shoreline adjacent to the Lake Ridge Drive neighborhood and the southern portion of “Little River” to the northeast (southern thick black dashed line on map). These shallows are about a quarter mile wide and, on Aug.24, had much of the flooded surface covered by vegetation, including many tall and dense stands of dog fennel (a sign that part of the area was only recently flooded). These stands visually isolated the northern and southern sections of the lake, and the vegetation likely reduced flow between north and south, but the area could still be crossed via a few very narrow boat channels.

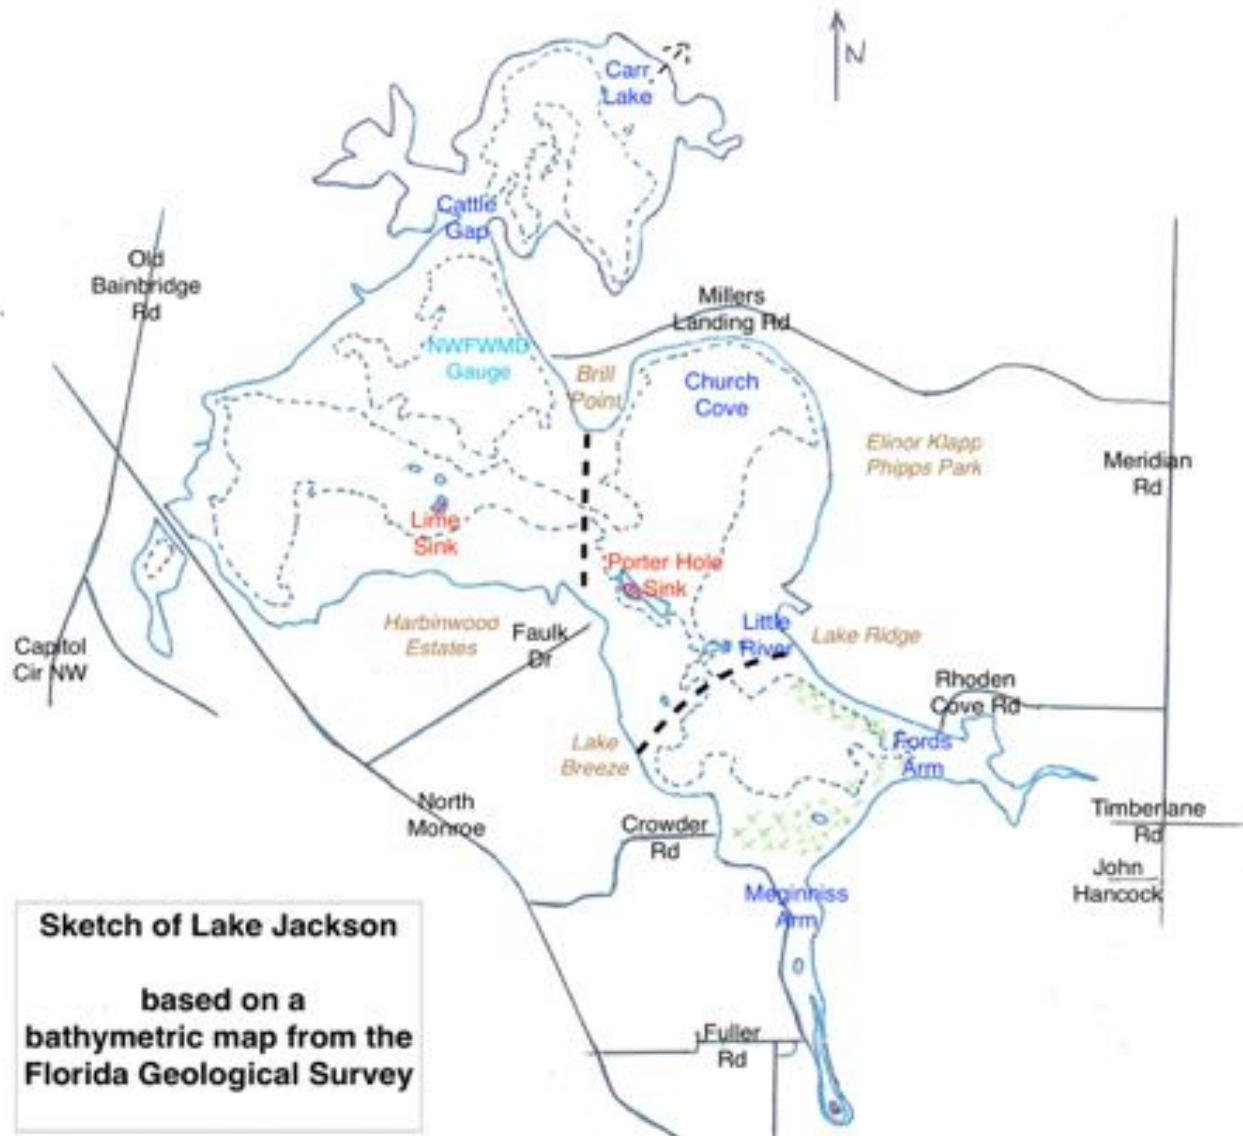
- The continuous blue line represents the mean lake level, around 86 ft msl.
- The dashed blue line within represents the contour line 9 ft below mean lake level, or close to 77 ft msl. Areas between the continuous line and the dashed line, or between two dashed contours are shallower. On Aug. 24, water filled the sub-basins within the dashed lines, and flooded some of the shallower areas by about 1 ft. Thick black dashed lines show the saddles and shallows mentioned in the text.
- Depressions, such as around Porter Hole Sink, or in South Meginniss Arm, are represented by closed blue contours. Sinkholes that are presently active (Porter Hole) or inactive (Lime, Meginniss) are patterned red.
- Continuous black lines represent roads.
- Green markings refer to algal bloom and vegetation mentioned in the text.

The feature article “The Dry-Down of Lake Jackson” talks more about the lake’s bathymetry.

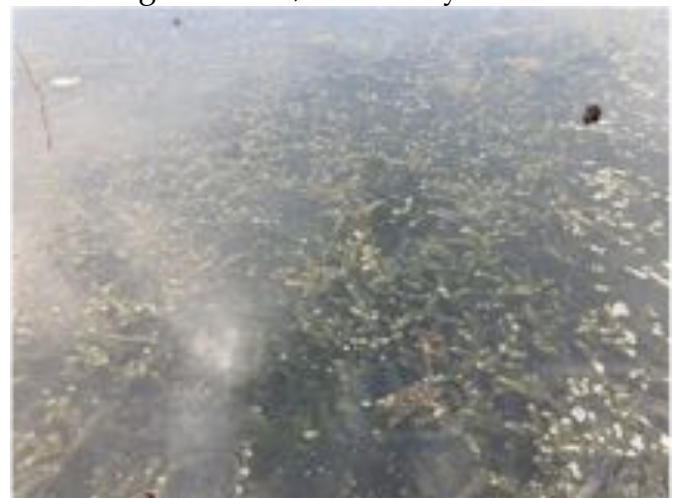
Topped out hydrilla along shore of the Southern Lake

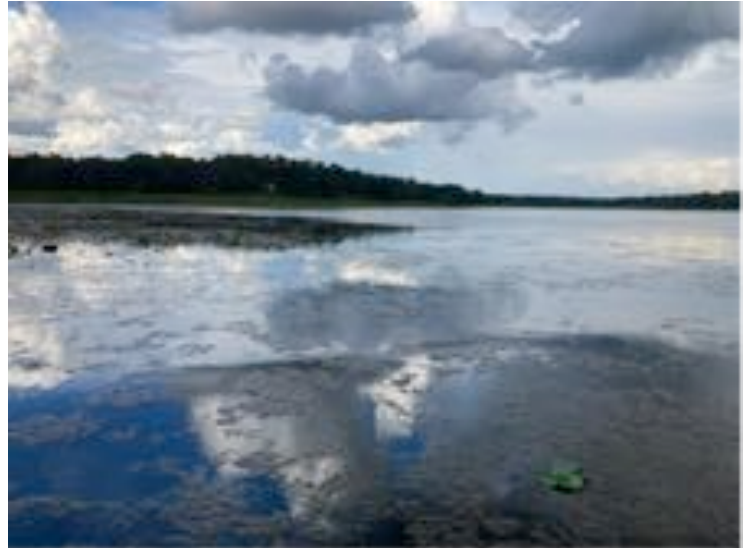
Algae mats in Fords Arm – August 23, 2022

The algae mats observed in the Rhoden Cove area and elsewhere in the southern part of Lake Jackson (green crosses on the map) looked like a blue-green algae bloom, aka a Harmful Algal Bloom (HAB) or cyanobacteria bloom (i.e. not technically related to an alga). Because such blooms can release toxins, there is an online procedure to report them for testing to the Florida Department of Environmental Protection (FDEP), using their Algal Bloom Dashboard, <https://floridadep.gov/AlgalBloom>. This procedure was followed, FDEP went onsite on Sept. 7, confirmed the Algal Bloom, identified the dominant taxon as a genera of cyanobacteria called *Plectonema wollei* (*P. wollei*), took a sample and had it tested.

Thankfully no toxins were detected, as posted on Sept. 9. By the time FDEP went onsite again on Oct. 13, the weather was cooler and about 2.5 in of rain had fallen. No HAB was observed, a sample was nevertheless taken and no toxin was detected.

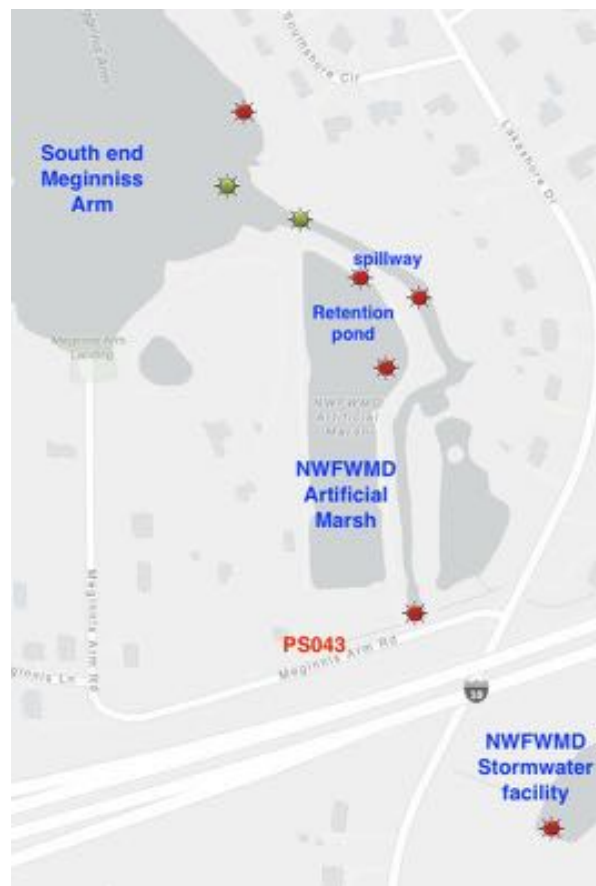
Area near spill (PS043)

red dots: City *E. coli* sampling
green dots: FoLJ *E. coli* sampling

As our February issue was in press, we learned of a major sewage spill off Meginniss Arm Rd that occurred on Feb. 5, 2022, following a leak at Pump Station 43. Fortunately for Meginniss Arm and Southern Lake Jackson, the discharge was close to the part of the NFWMD stormwater facility located north of I10 and most of the spill went through the artificial marsh into the retention pond at its northern end, while some of it flowed directly into the canal that flanks the eastern side of the facility, and from it into Southern Meginniss Arm.

Thanks to a prompt remediation response by the City, the canal entrance was blocked, a very large amount of polluted water was pumped out of the system, and the area was cleaned. Nevertheless, a fish kill was reported near the source of the spill and microbial samples showed extremely high values of *E. coli* contamination in the artificial marsh over several days, eventually concentrated in the retention pond at the end of the system. Initially, high *E. coli* values were also measured in the canal and in Meginniss Arm beyond. On Feb. 14, the City declared values back to normal in Meginniss Arm (red dot within south end of Meginniss Arm) and monitoring stopped.

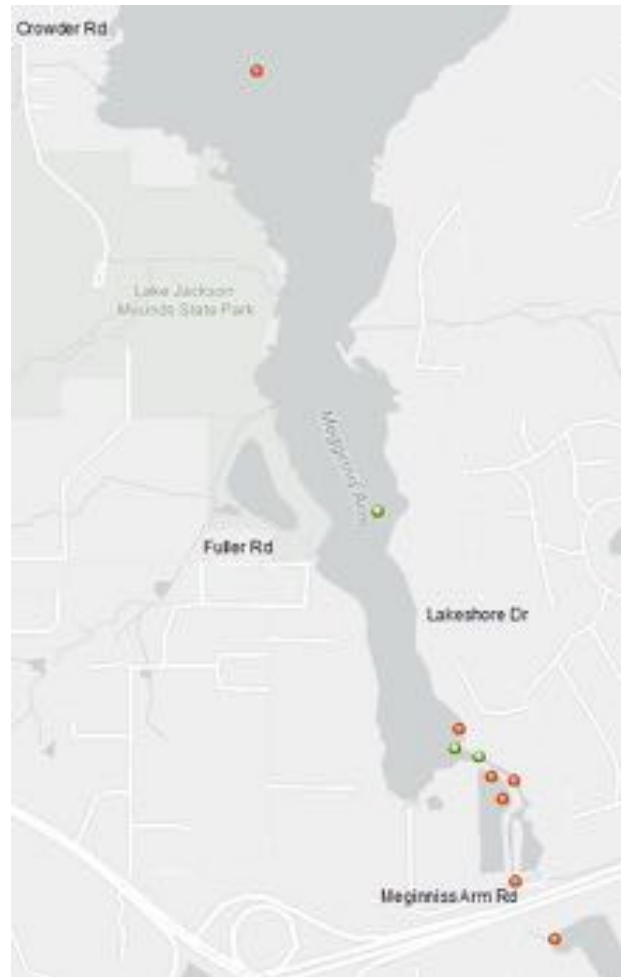
Zoomed-out map of Meginniss Arm with the extra more northern sampling locations mentioned in the text to the left.

Based on the elevated *E. coli* values found north of Fuller Landing within Meginniss Arm and in the open lake beyond, the bad news is that some contamination is likely to have reached the open lake. The good news, however, is that samples taken near Porter Hole Sink by a third party returned 1-digit values, so it does appear that an ecological catastrophe was avoided as far as the open lake is concerned.

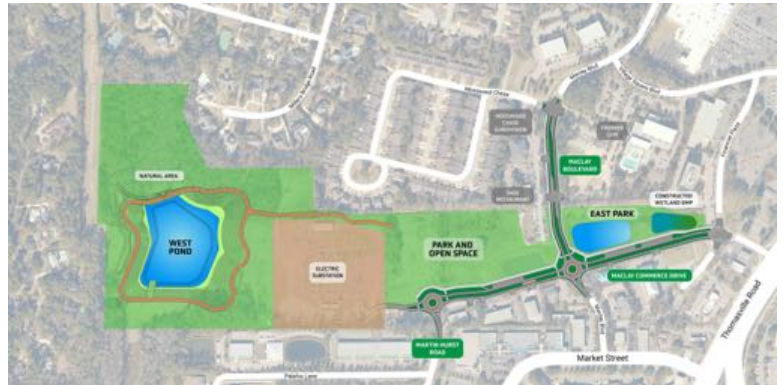
Stormwater from that area reaches Lake Jackson via Lexington Creek, the stream to the left of the red bullet on the map above, which flows into Fords Arm. That stream has been observed for years to carry large amounts of silty water into the lake following large rain events, even after a small stormwater feature was built at the corner of Meridian Rd and John Hancock. The creek also has a history of periodic E-coli contamination (see Leon County Water Quality Report for Lexington Creek <https://cms.leoncountyfl.gov/Home/Departments/Public-Works/Engineering-Services/Stormwater-Management/Water-Quality-Data>.)

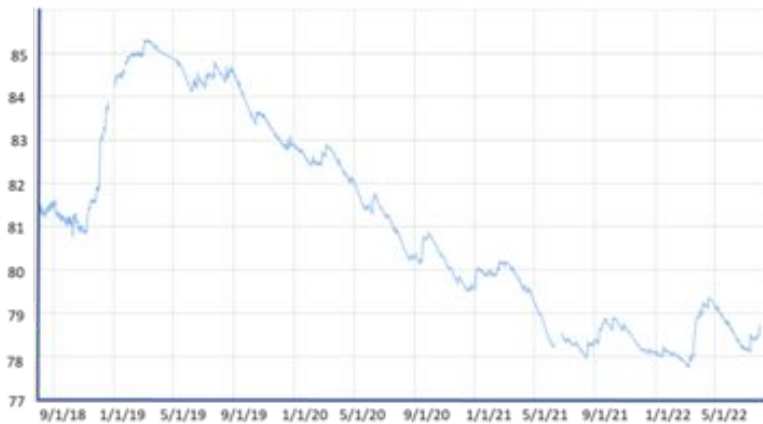
Figure 1 - Lake Jackson water surface level (ft msl) at the Miller Landing gage (based on data from the Northwest Florida Water Management District - <https://nwfwmd.aquaticinformatics.net>)

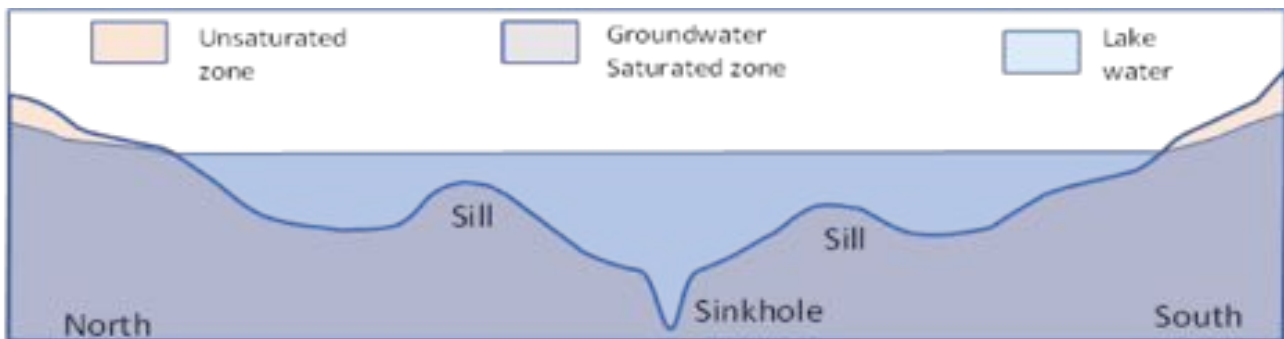
To understand these observations, a simplified representation of a lake is illustrated in a series of cross-sections. Like Lake Jackson, the bottom of this lake is uneven with shallow "sills" dividing it into a north, central and south basin.

Figure 2 – Cross-section of a lake divided into three

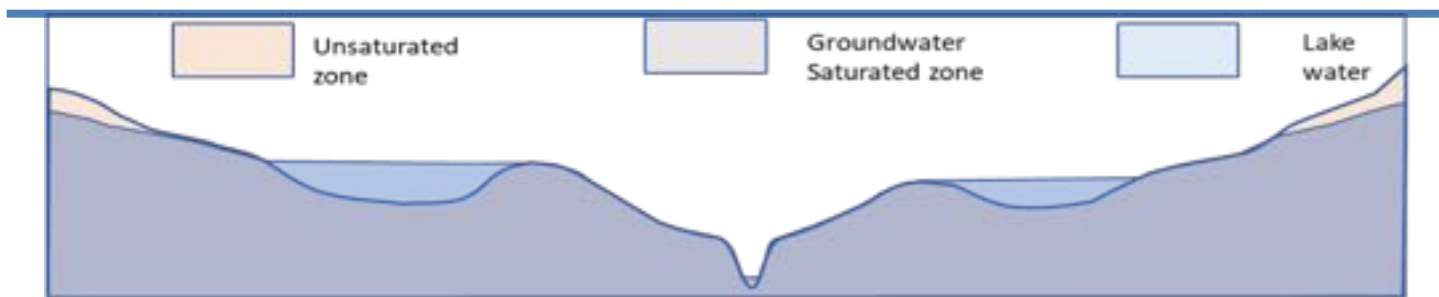
As a dry-down period develops the lake level drops and in major events the level drops below the elevation of the sills as shown in Figure 3. The lake is divided into a series of ponds which can be at different levels depending on the elevation of the sills. As shown in Figure 3, the basin with the sinkhole can dry completely while the other ponds remain. This is the case in Lake Jackson.

Figure 3 - Illustration of a dry-down event in lake with shallow basins divided by sills

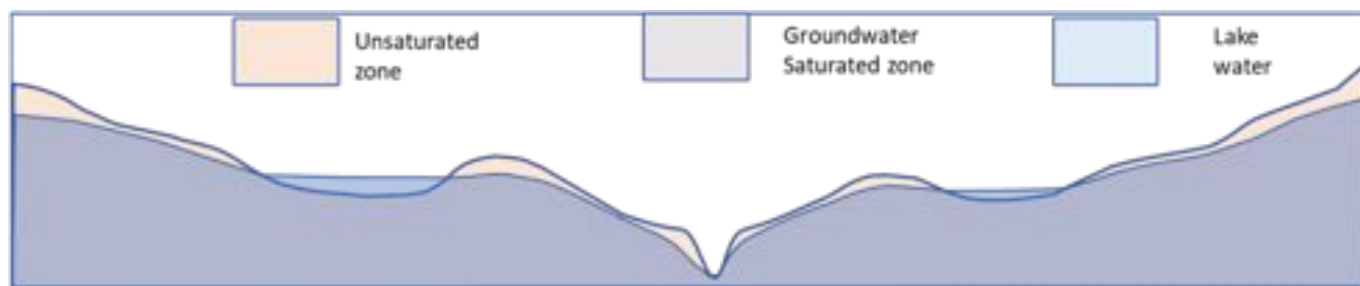
Figure 4 shows that, as the conditions of the dry-down continue the individual ponds respond independently. Ponds adjacent to relatively large upland drainage areas tend to remain near the level of their sill. Other areas of the lake bottom can dry completely and these tend to quickly become vegetated. In the idealized cross-section of the figure the central basin, which has the

Figure 4 - Additional drying of lake bottom during prolonged dry-down.

sinkhole, is clearly of smaller volume than the whole lake. The sinkhole can drain this pond completely. However, rain events can cause adjacent ponds to overflow their sills and the central basin to fill quickly. This has happened several times in the last year and a half, with Porter Hole Sink and its basin flooding and the water level there rising more than 10 ft. We explain later how little rain it takes to accomplish that.

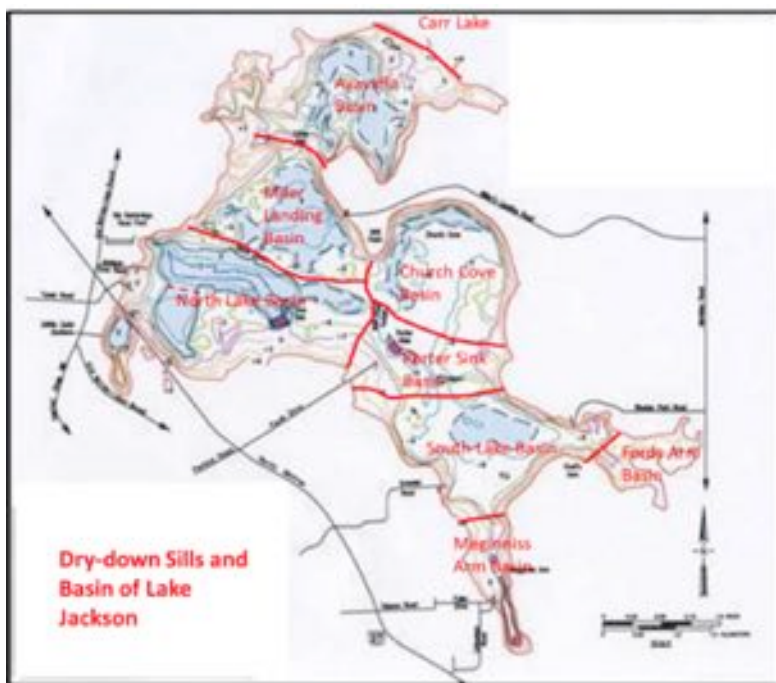
Figure 5 shows the more complex bathymetry of Lake Jackson, using a Florida Geological Survey map produced in 2000 to illustrate the 1999 dry-down event (Balsillie, Evans, Wagner). Red lines have been drawn over the various sills (or “saddles”), which begin to emerge when the water level drops below 79 ft, thus segmenting the lake into distinct sub-basins. The saddles are generally broad features, 100s to 1000s of feet across. The redlines are placed along the “drainage divides” at the very crests of the saddles.

Figure 5 – Lake Jackson bottom configuration

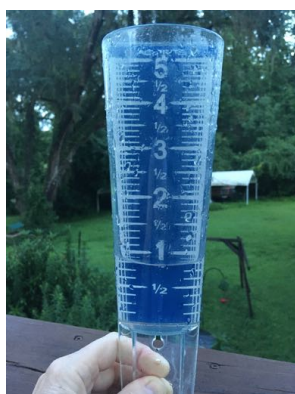
Rain falling over a narrower area is also why “1 inch” of rain is taller at the bottom than at the top of your rain gauge if the gauge has the tapered look of the one to the left. By contrast the scale does not change on cylindrical rain gauges such as the one on the right.

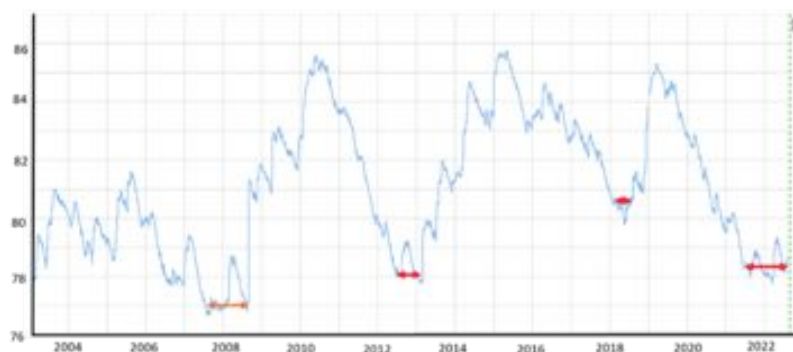
Figure 6 – Lake Jackson water levels (ft msl) with red arrows highlighting dry-down low-stand periods

Figure 6 is a time-series record of water levels measured at the NFWMD gauge near Miller Landing. Clearly each of the preceding dry-downs has been followed by a refilling episode so there can be some confidence that Lake Jackson will once again have a normal amount of water in the future. Red arrows on this figure indicate the duration of the prolonged dry-down stage of the present conditions and three previous cycles.
